Inspection Report
Minerals Regulatory Program
Report Date July 21, 2005

Mine Name: Green River Project
Operator Name: Green River Project, LLC

Permit number: S/019/058
Inspection Date: May 18, 2005
Time: 5:20 to 5:45 PM

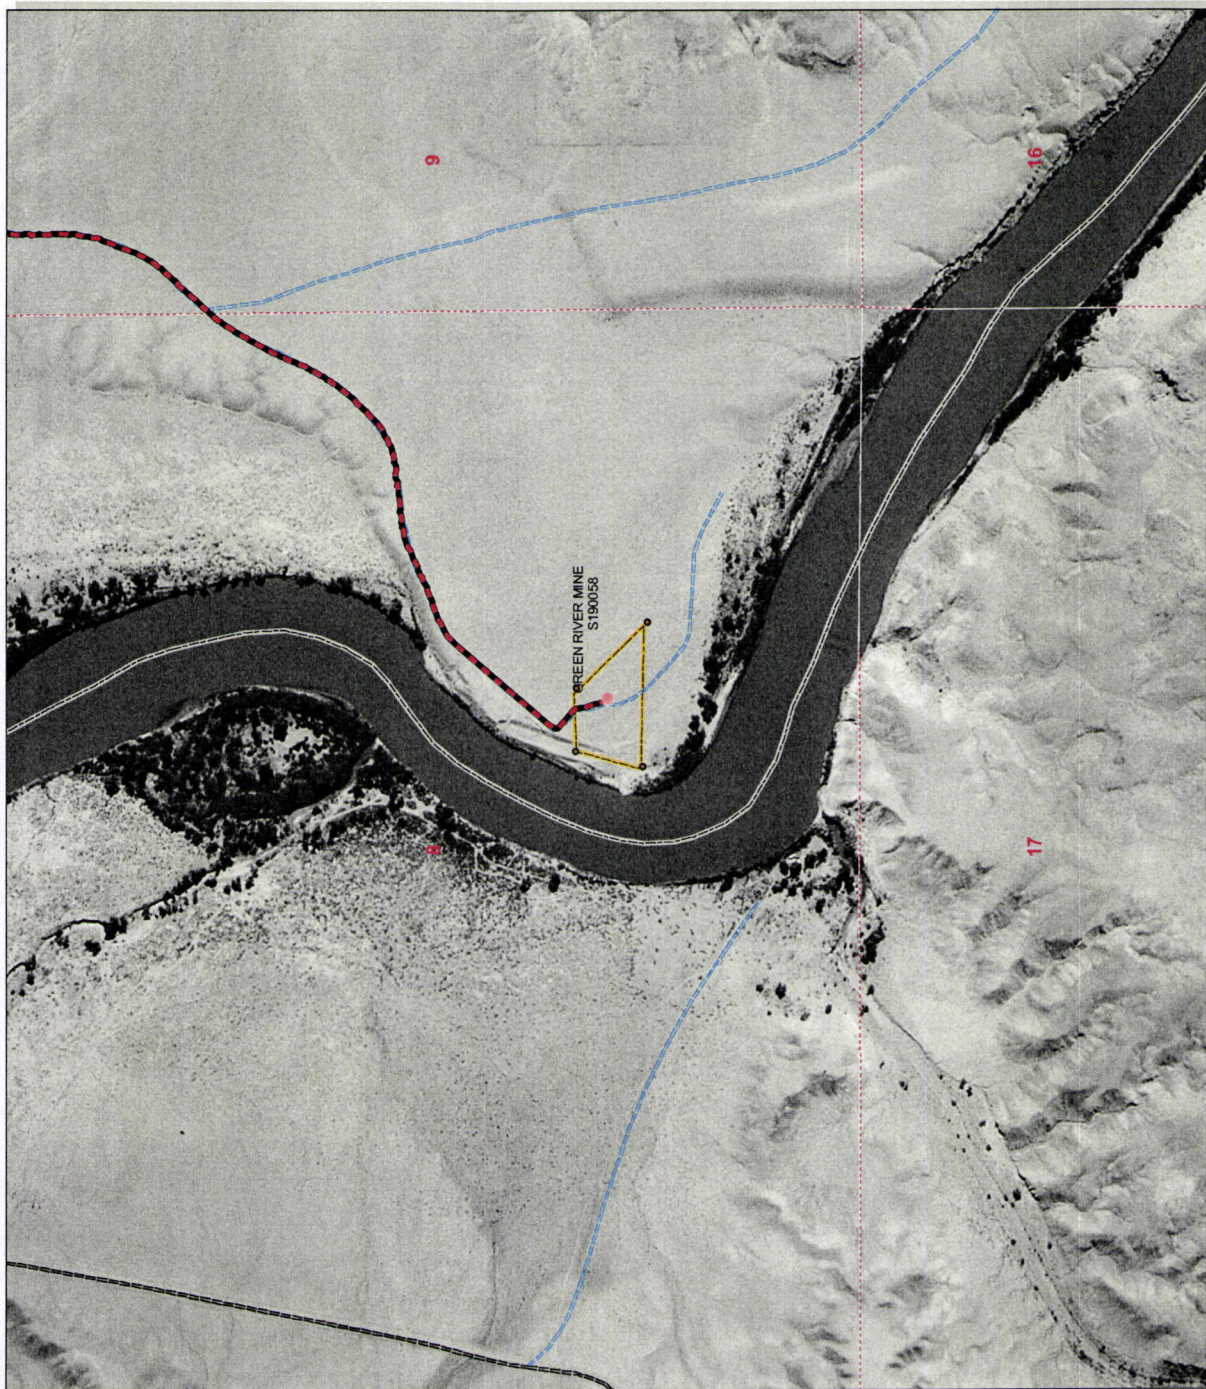
The other map shows the area of the proposed mine site. The NOI included four points that determine the boundary of the disturbed area, and these points are plotted on this map. The NOI shows the disturbed area as a rectangle, but the coordinates do not form a rectangle.

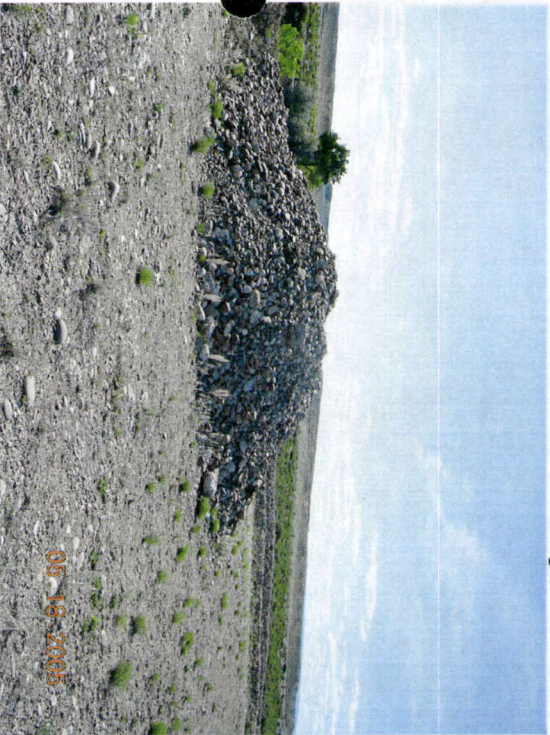
The area is an alluvial deposit adjacent to the Green River, so the soils are coarse-textured with a lot of cobbles. There are some areas of previous disturbance, including holes, mounds, and trenches (Photos 1, 2, and 4), but little of this disturbance is within the area the operator staked. There is also some old equipment in the area (Photos 4 and 6), but I do not believe any of it was in the area the operator intends to disturb.

Photo 1. Some of the previous disturbance. This is not in the area staked for the new mine.

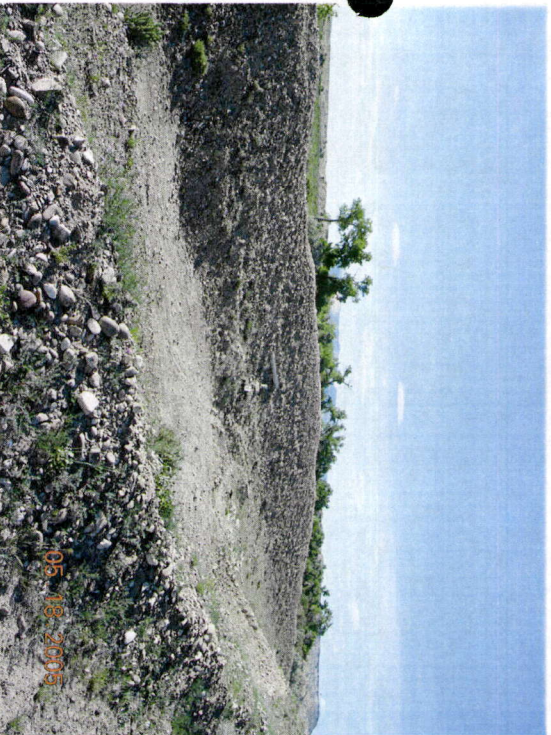
Photo 2. More previous disturbance. This is also not in the area staked for the new mine.

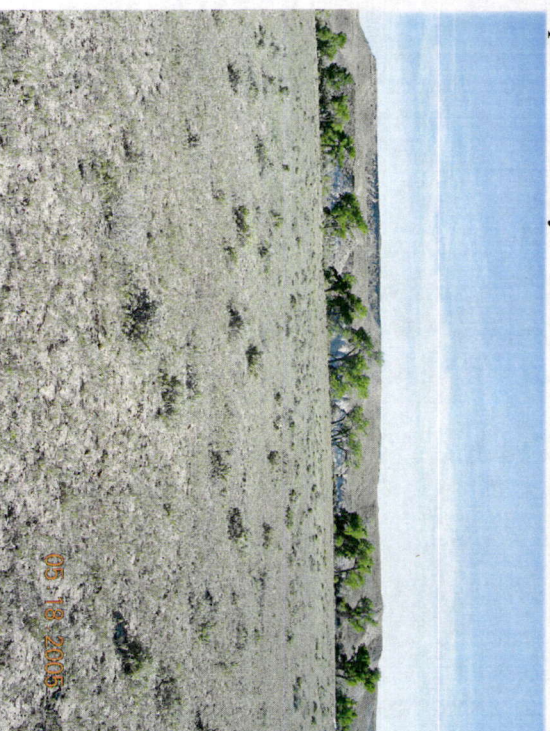
Much of the area is vegetated with native species, including shadscale and snakeweed (Photos 3 and 5), but there is also a lot of cheatgrass, particularly in disturbed areas.

Photo 3. Part of the area proposed to be disturbed.

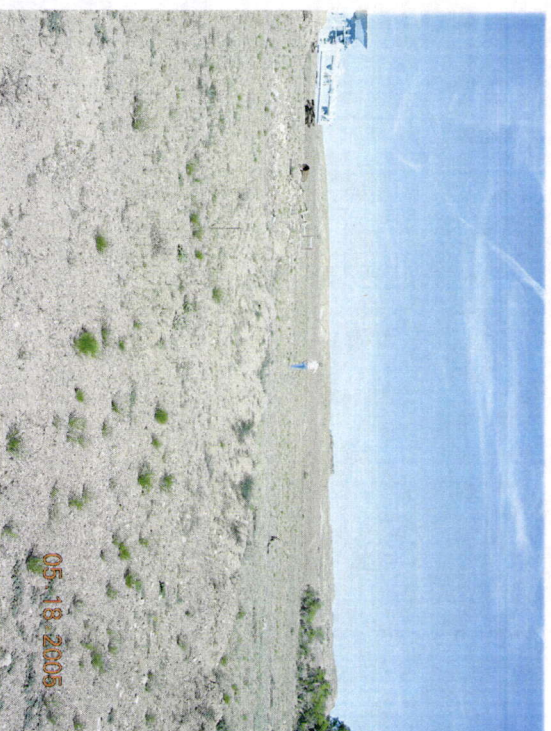
Photo 4. Some old equipment and disturbance near the area proposed to be disturbed.

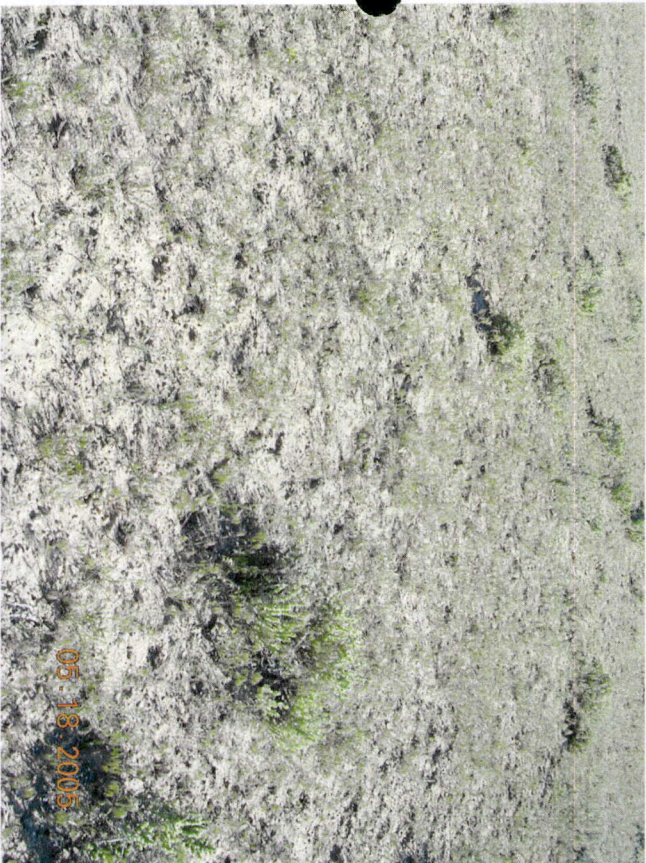
Photo 5. An undisturbed area. Most of the vegetation is native perennial shrubs and grasses, but there is a lot of cheatgrass in the area.

Cheatgrass tends to quickly invade disturbed areas where the soil have an abundant seed supply and good drainage. It is important that the operator seed topsoil stockpiles with an interim revegetation seed mixture and that disturbed areas be reclaimed and seeded as soon as possible after they are no longer needed for mining. If this is not done, I anticipate the entire area will be covered with cheatgrass.

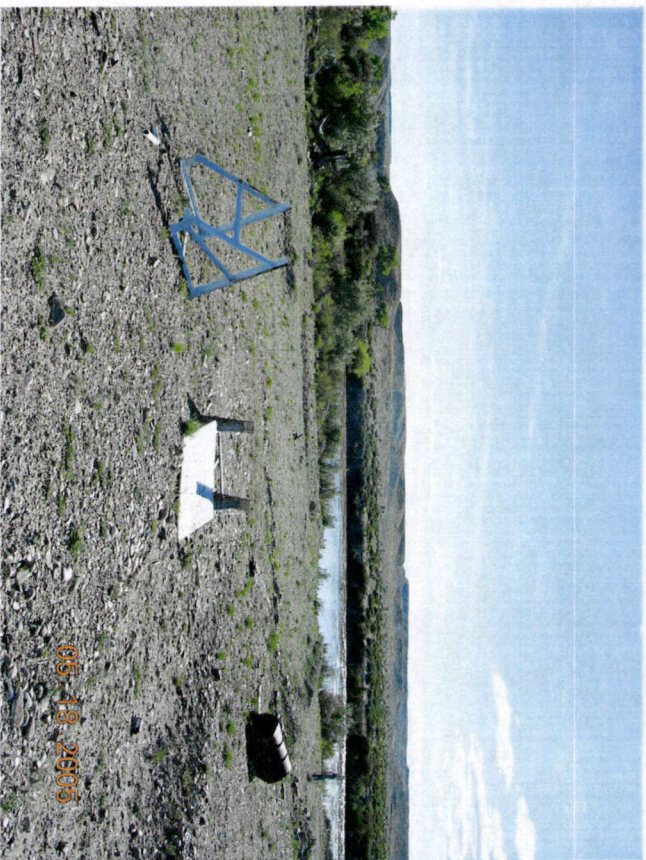
Photo 6. Leftovers from the previous operation.
